# Evaluation of Precut Transverse Cracks for an AC Pavement in Interior Alaska

Jenny Liu and Sheng Zhao

University of Alaska Fairbanks

2016 CESTiCC Workshop, Bozeman, Montana

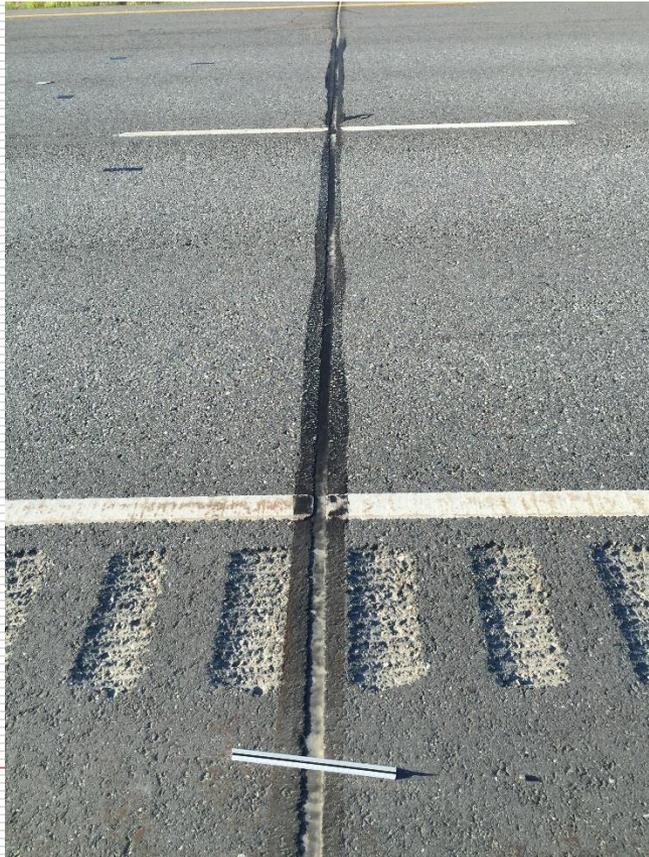
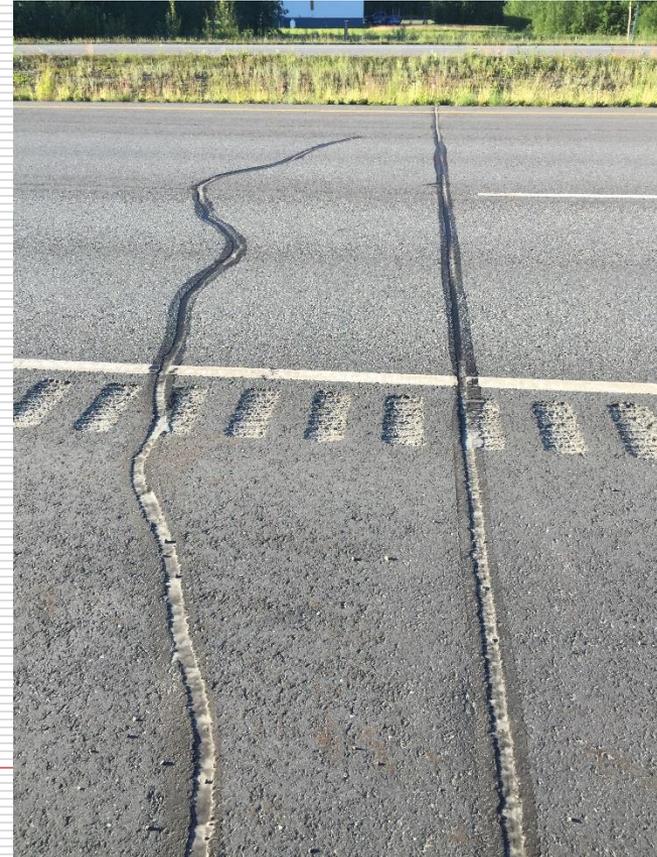
# Crack Filling Observed on One Section

- ❑ “Cut on existing cracks” section with 1.5 in cut depth from Moose Creek project was maintained with crack filling

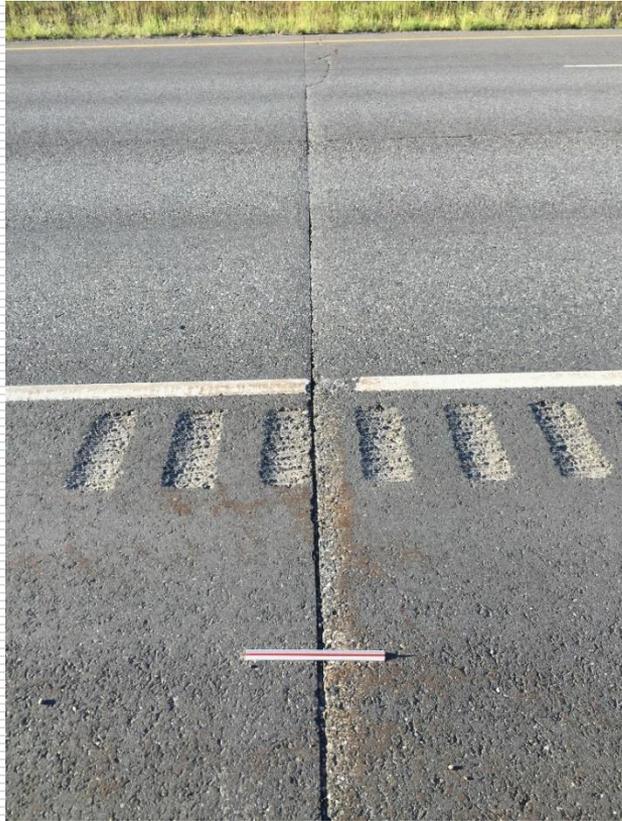
Active Precut

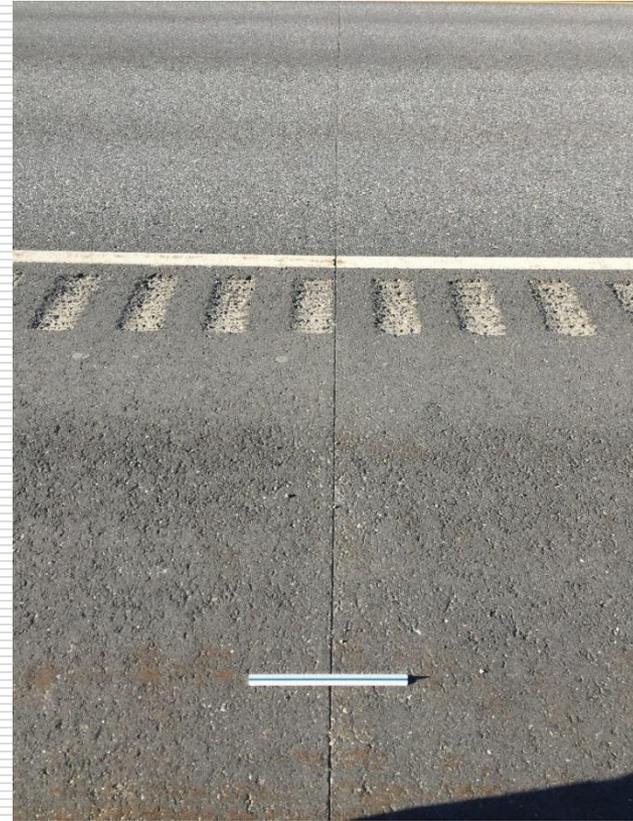
Non-active Precut

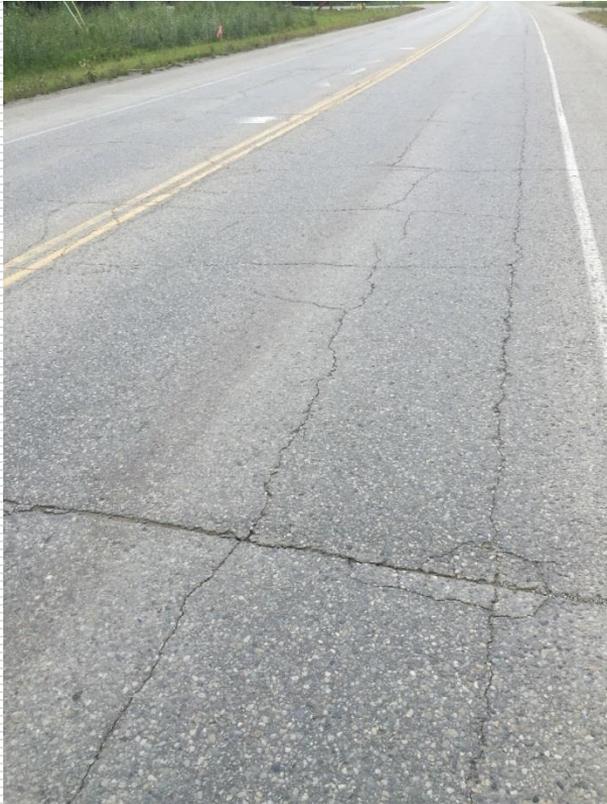
Block Cracks

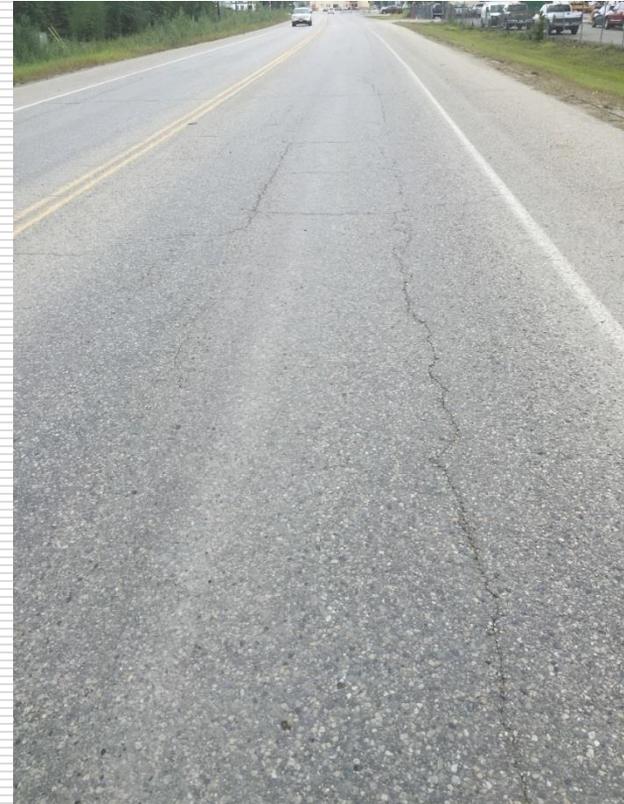
Longitudinal Cracks

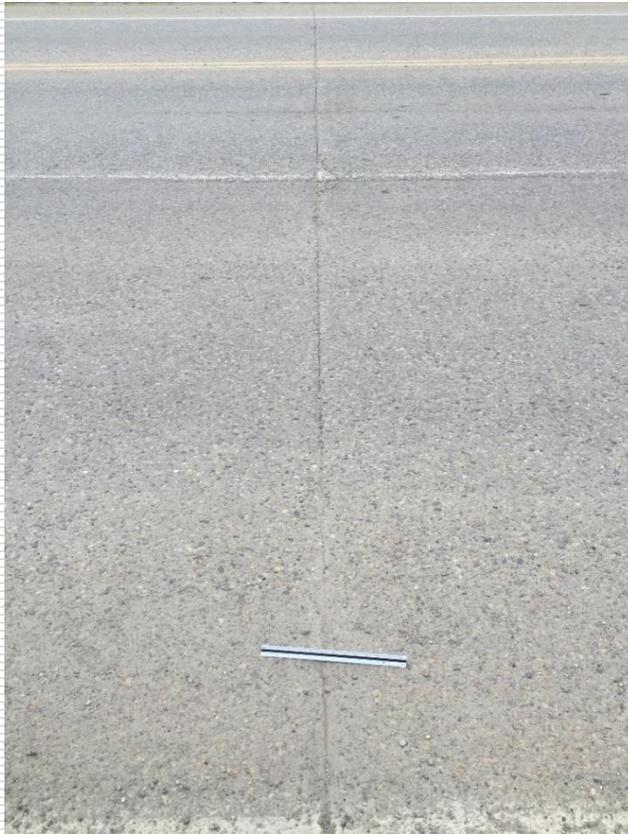
Non-active precut

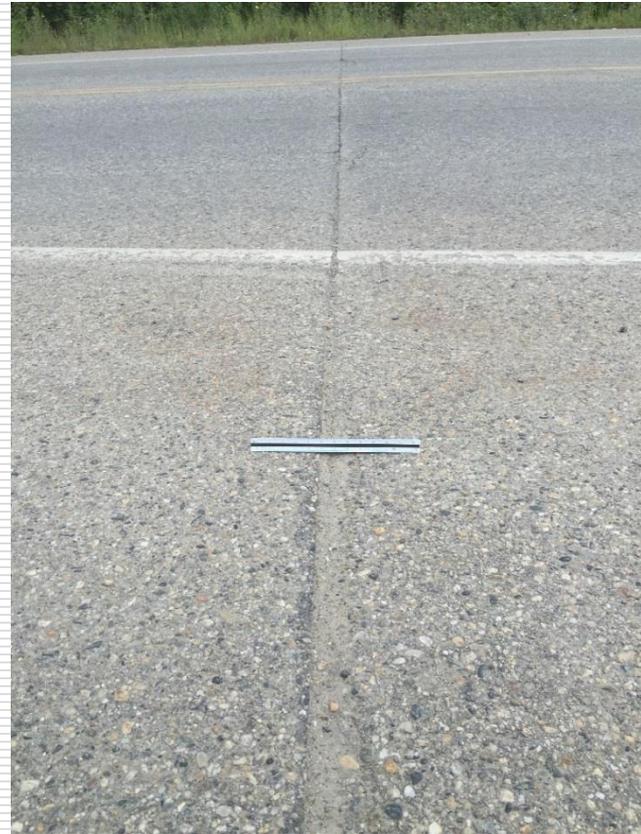
Active precut

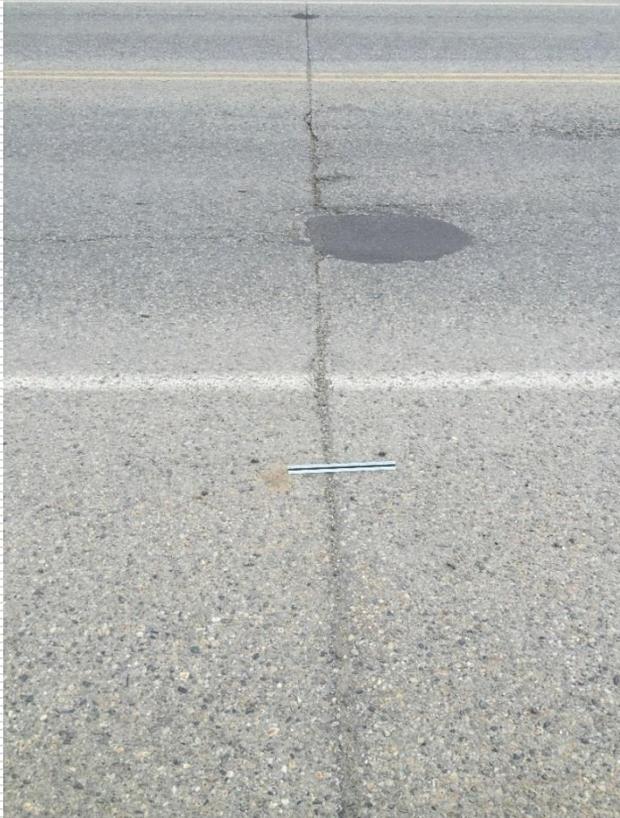
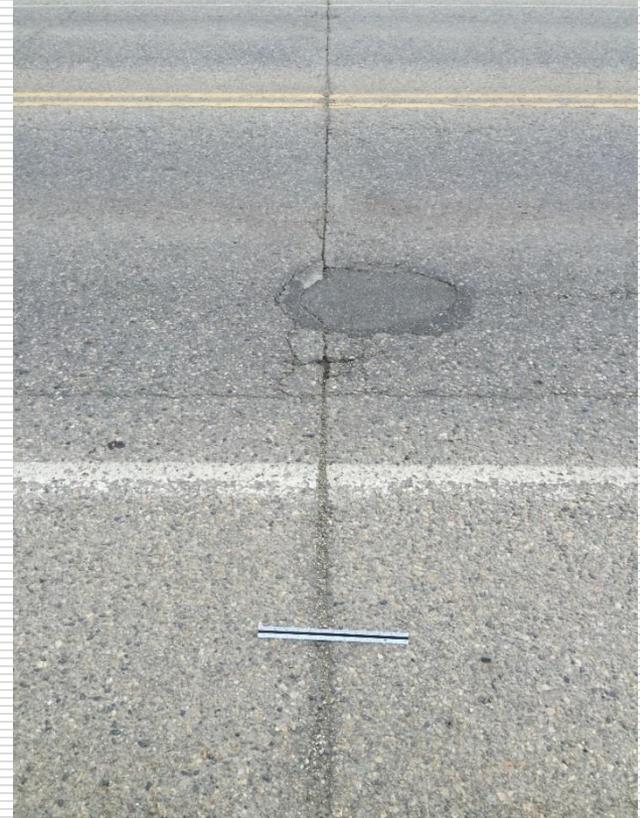
Potholes
